RECLAMATION PROPOSAL

LARA WASTE/ORE PILES

LARA PROPERTY

August 21, 1989

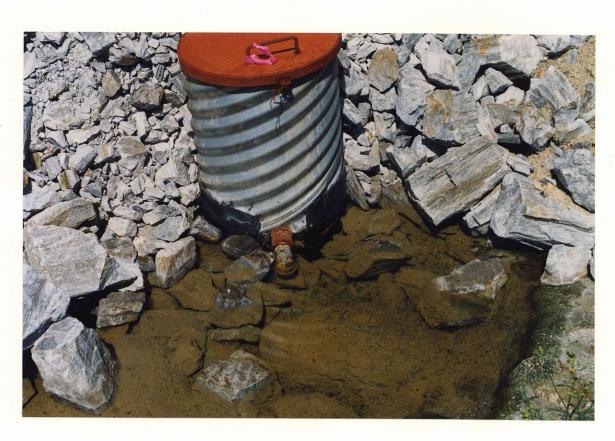
FIGURE 8: DRAINAGE CULVERT AT LOW CORNER OF WASTE/ORE PAD (JULY 27. 1989)

The contoured nature of the pad allows this water to accumulate at the southeastern corner of the pad (Figure 8) prior to release to the monitoring/treatment pond (Figure 2, 9). After a period of heavy rainfall, the monitoring/treatment pond is designed such that it overflows into the forest area between the pond and Solly Creek (Figure 10, 11). To date, overflow has only been noted in late fall and early spring. There has been little or no drainage from the waste/ore pad to the monitoring/treatment pond since March and no release of water from the monitoring/treatment pond to the forest since March. The storage pad, menitoring/treatment pond and interceptor ditches were designed so that there is no direct discharge of water from around the site into Solly Creek.

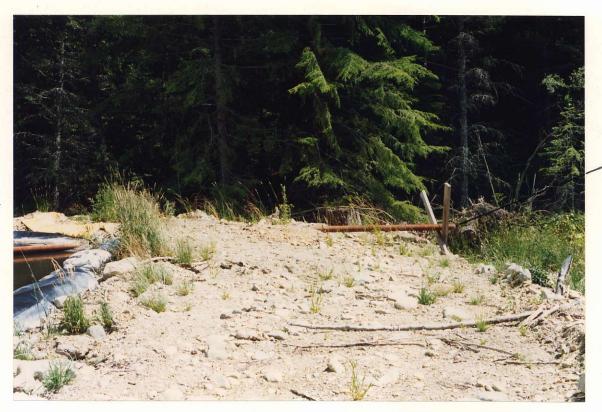
Discharge pipe

FIGURE 10: OVERFLOW DRAIN FROM MONITORING POND

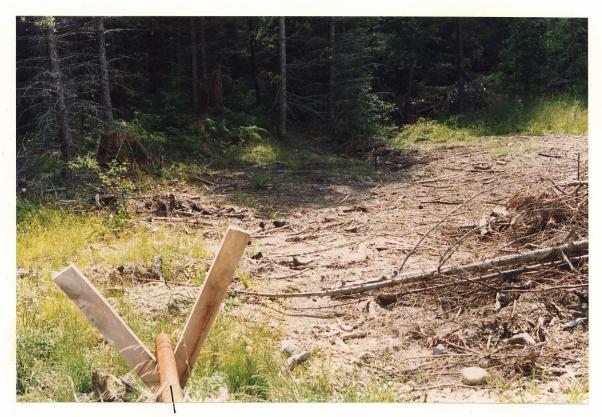
Discharge Pipe

FIGURE 11: DRAINAGE AREA AS SEEN FROM MONITORING POND
